REPORT NO. NADC-81075-60

**SHIPBOARD EXPOSURE TESTING**

E. J. Jankowsky and S. J. Ketcham  
Aircraft and Crew Systems Department  
NAVAL AIR DEVELOPMENT CENTER  
Warminster, Pennsylvania 18974

PROGRESS REPORT  
AIRTASK NO. WF61-542-001  
Work Unit No. ZM501

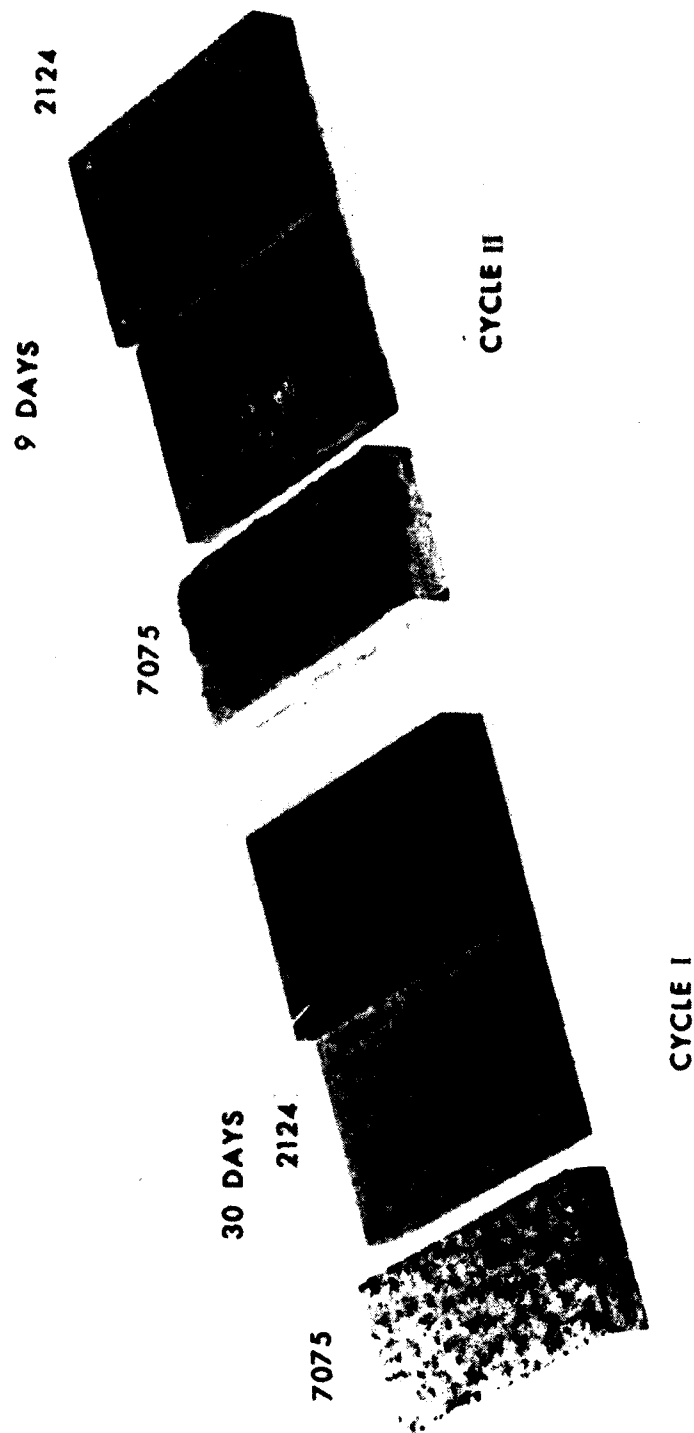
Figure 14. Cycle I and Cycle II — Cyclic  $\text{SO}_2$  — Salt Spray

In the cyclic  $\text{SO}_2$ -salt-spray tests, Cycle I, the spray-soak- $\text{SO}_2$  cycle, resulted in very little exfoliation, mainly surface attack even after 30 days of exposure. Cycle II simulated carrier exposure attack more closely than Cycle I with both 7075 and 2124 exfoliating in relatively short times. Cycle III came closest to giving the same type of attack as carrier exposure. The major differences were the somewhat darker color of corrosion products in the laboratory test and a slight reversal of attack. On the carrier, 2124 was more severely attacked than 7075 while the reverse was true in the laboratory test. Cycle IV formed more surface lumps than the other cycles without distinct layering, 2124 was very black after a few days of exposure. Results of cyclic exposure are shown in figures 14 and 15 for cycles I, II, and III.
